May 1st, 2024

Peach Lake Brook Survey Report

Little Bear Environmental Consulting, LLC

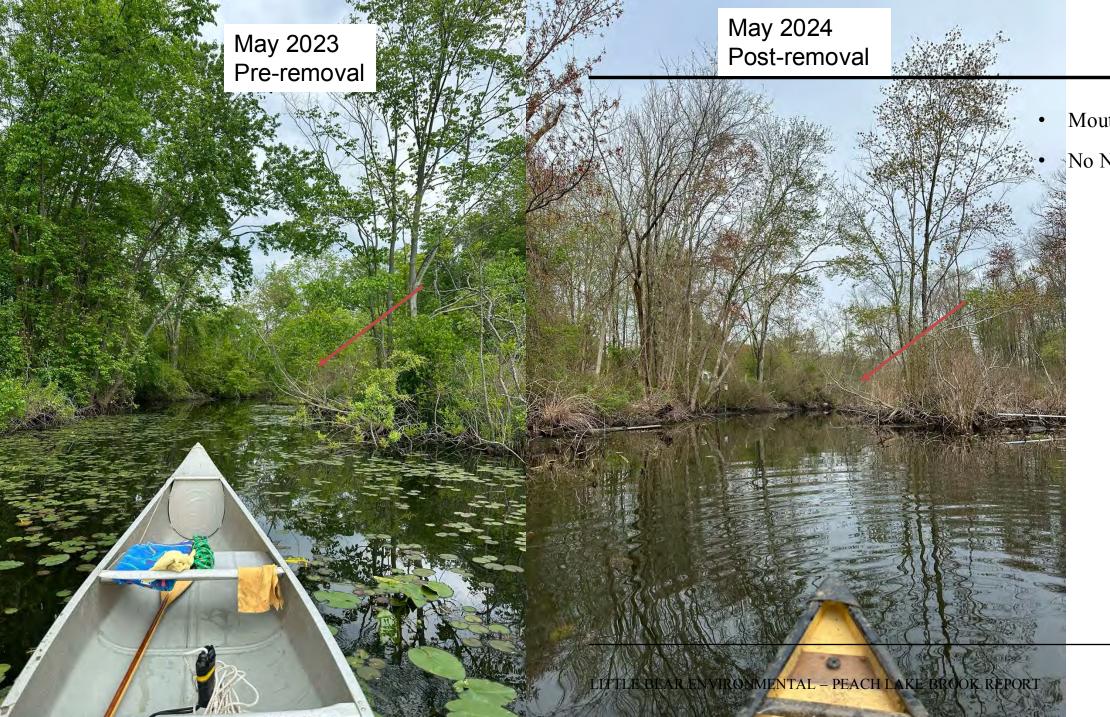
Mouth of Lake Outlet

No Nuisance densities

Sept 2023 Pre-removal

- At site 2 the channel of Peach Lake Brook splits into two and then rejoins, with an island formed in the middle.
- The western channel is the original path of the brook.
- An eastern channel was dug in 2016 to reduce the height of the lake, although proved ineffective due to the vegetation and debris stalling flows throughout the brook.
- Drone Photo: Little Bear Environmental (preremoval)

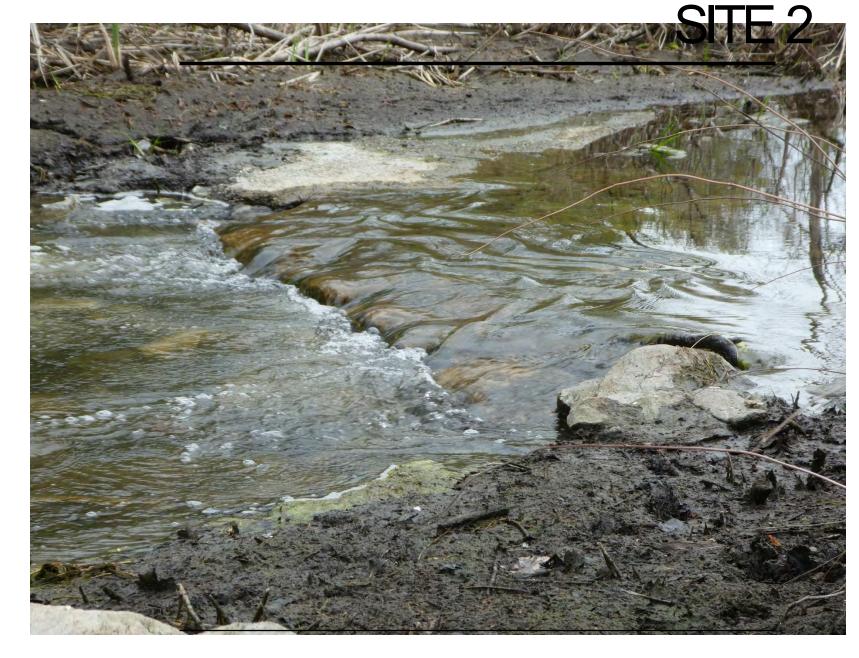
May 2024 Post-removal

• Photo showing the eastern channel with the unauthorized makeshift dam (left) and the original channel with the historic dam (right).

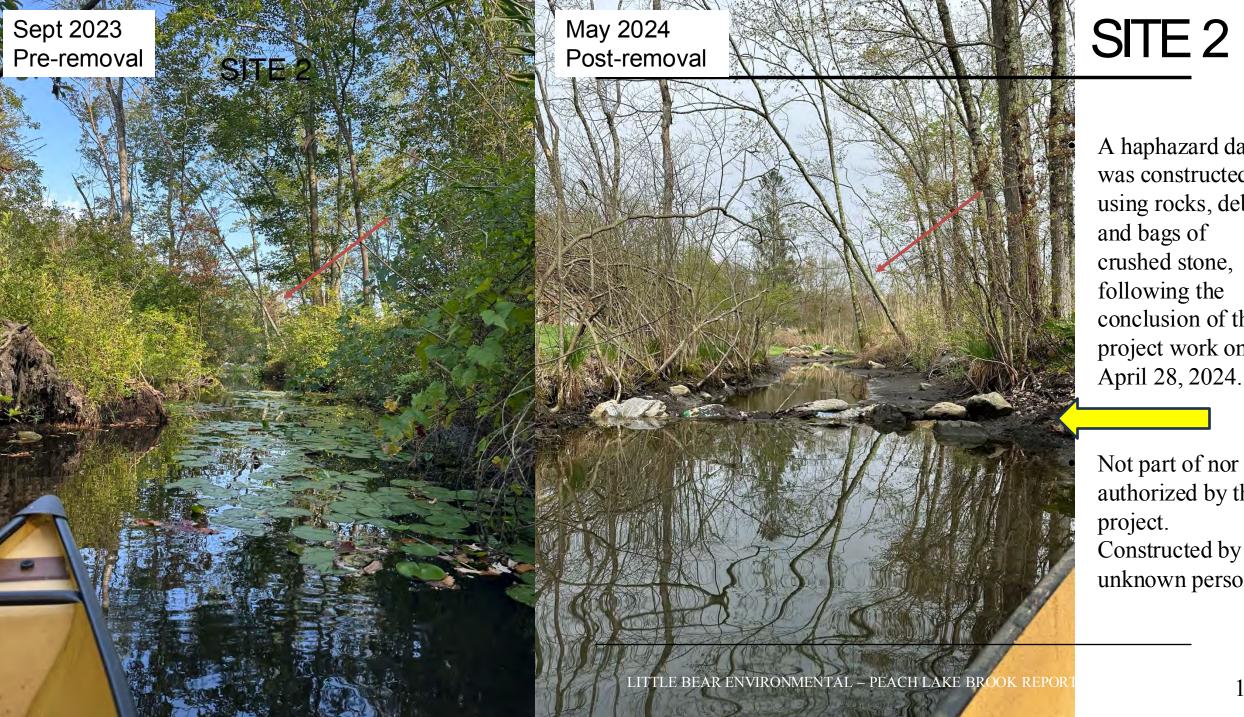
A haphazard dam was constructed using rocks, debris and bags of crushed stone, following the conclusion of the project work on April 28, 2024.

authorized by the Constructed by an unknown person.

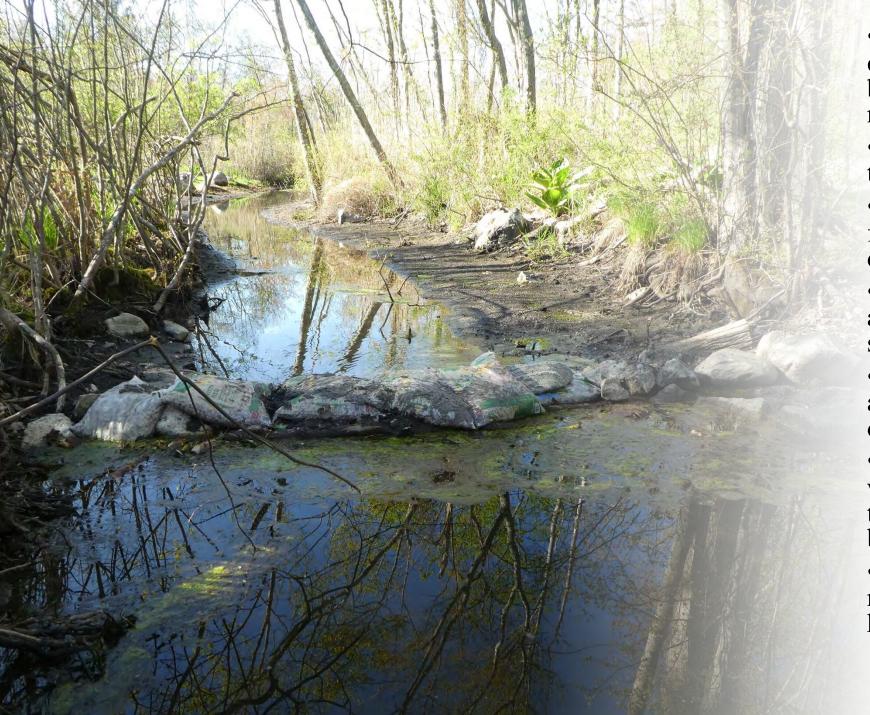
- A makeshift dam has been constructed along the eastern branch of the channel using bags of rock, blocking water flow
- This inhibits movement of fish through the channel
- This may obstruct organic debris from passing through the channel during storm events
- Filamentous algae mats have already begun to accumulate in the stagnant water
- The existing permits do not allow the construction or removal of structures
- Boats may not pass over this and will be forced to portage here or on the historic dam side to enter the brook
- Water depth on May 1st would not allow passage of boats of any kind without portage over the dam

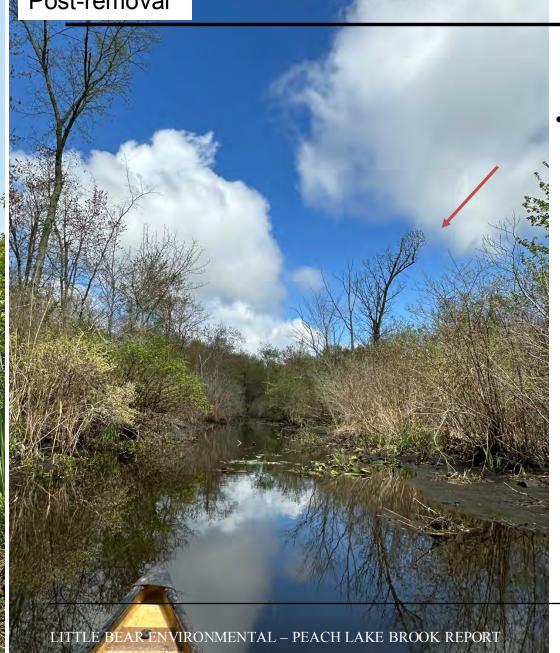
May 2024 Post-removal Site 30

Significant emergent vegetation removed, trace vegetation still present within channel

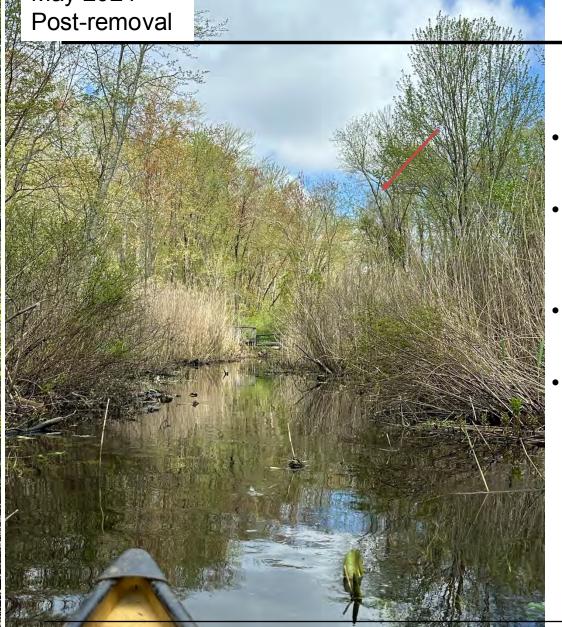
- No Nuisance densities
- Large woody debris removed from channel
- Water no longer stagnant
- No floating plants accumulating

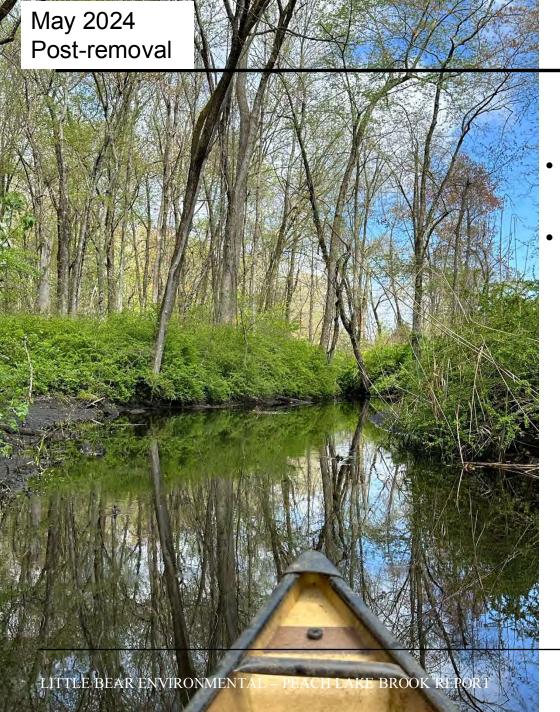
- No Nuisance densities
- Large woody debris removed from channel

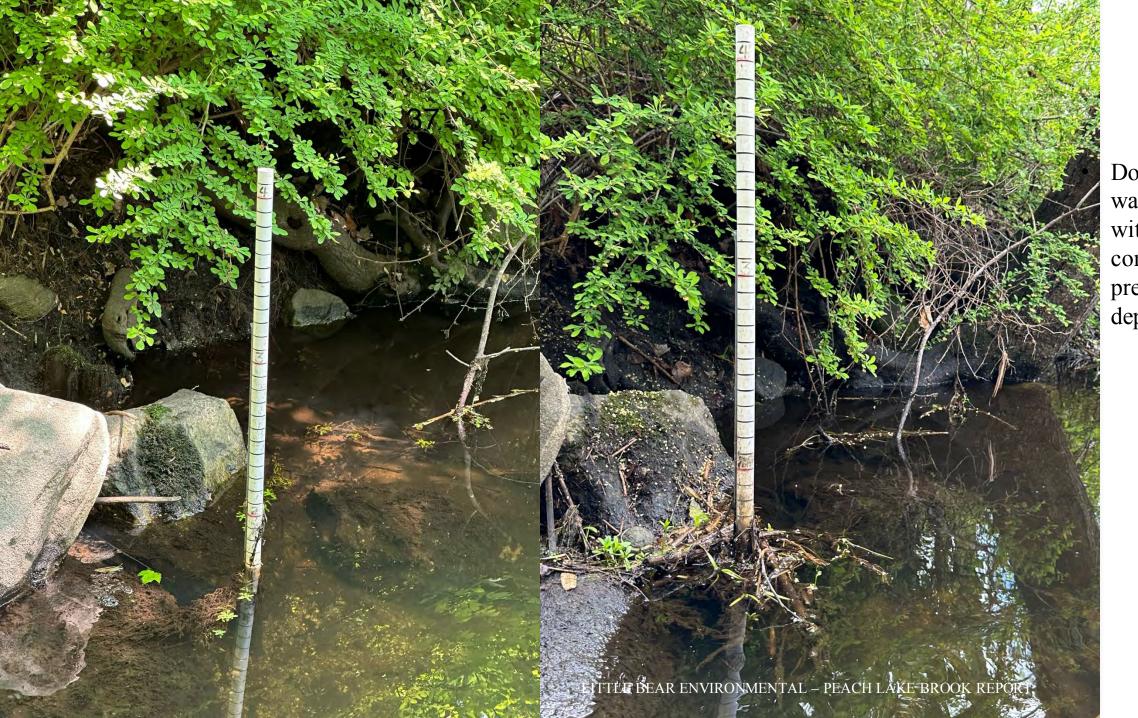
Downstream
water depth
within Brook is
comparable to
pre-management
depths

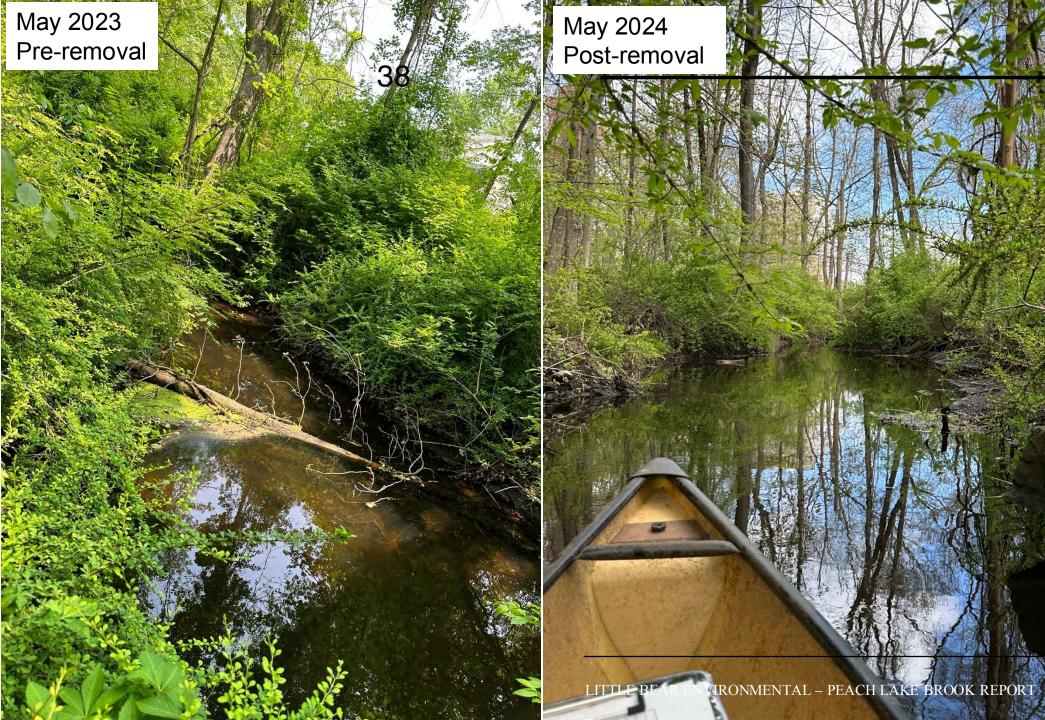
- No Nuisance densities
- Large woody debris removed from channel

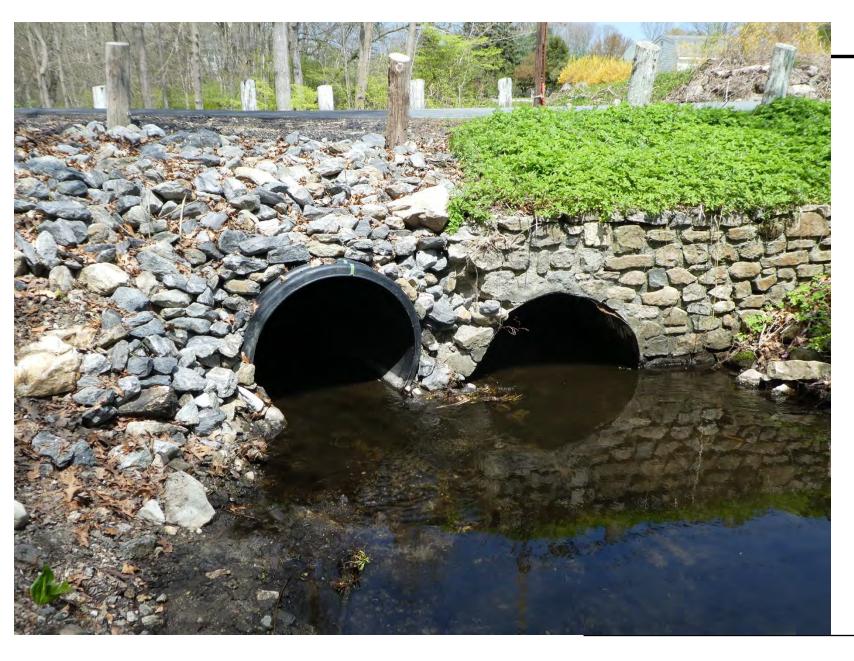
SITE 40

No Nuisance densities

Culvert has been upgraded since 2023 survey and now has two pipes.

Photo taken April 28th, 2024, courtesy of Bradley Schwartz, showing completed upgrade to culvert with two pipes.
