May 1st, 2024

Peach Lake Brook Survey Report

Little Bear Environmental Consulting, LLC

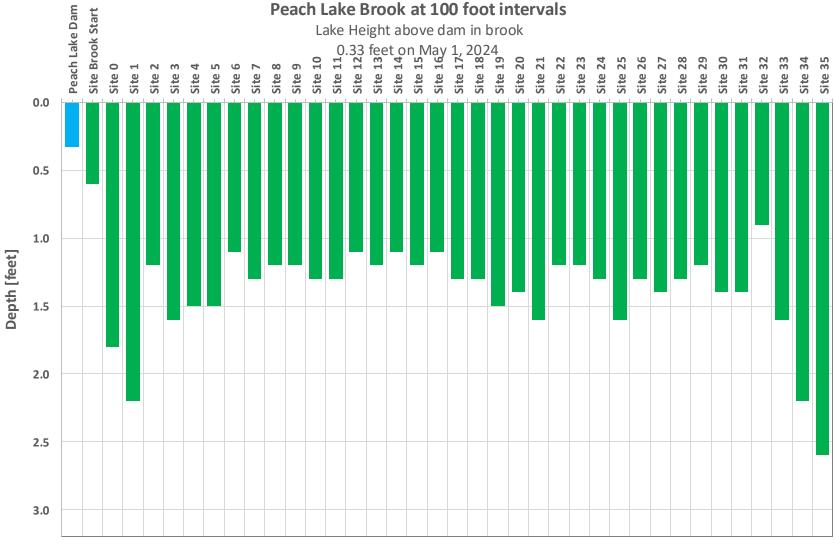
Water Depth May 2024

• Lake depth and brook depth were both significantly lower than 2023.

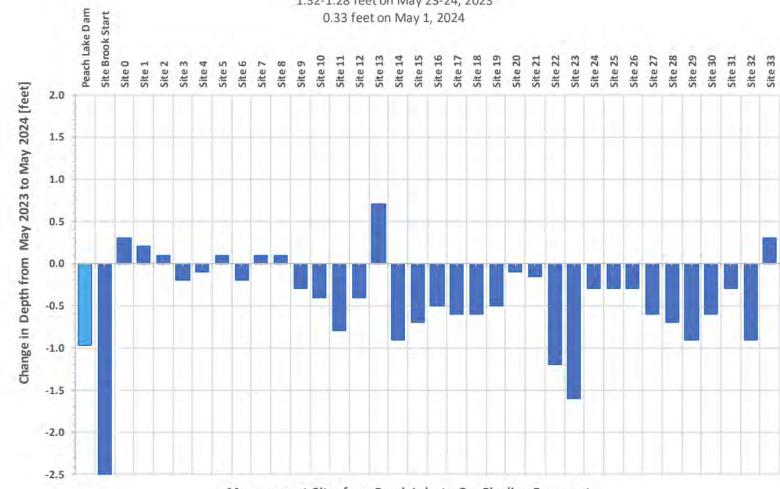
Water Depth Comparison

- Brook and lake depths were lower than 2023.
- Vegetation, large woody debris, and root pack have been removed, improving flows.
- Chart displays change in depth from May 2023 to May 2024.

Lake Height above dam in brook 1.32-1.28 feet on May 23-24, 2023 0.33 feet on May 1, 2024

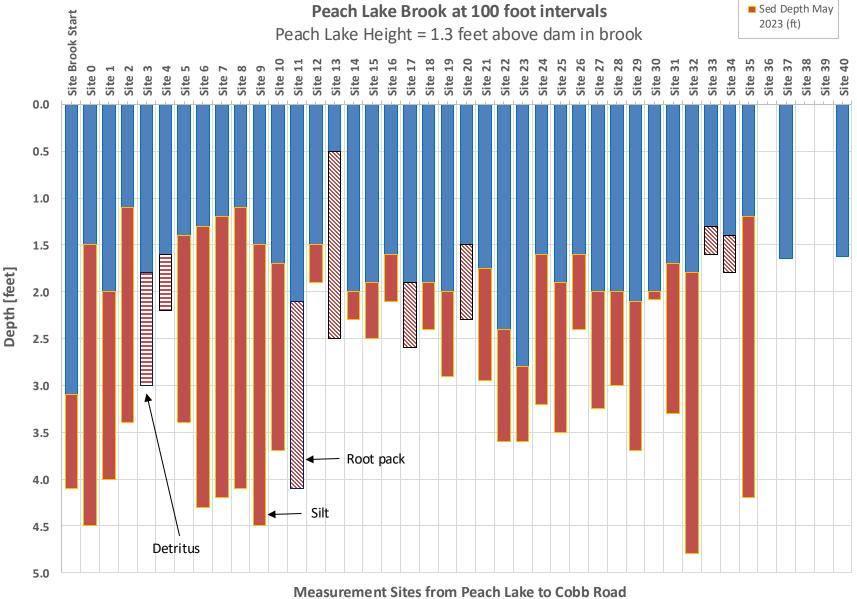
Water & Sediment Depth May 2023

• Significant accumulation of deep soft sediments, detritus, and root pack were present within the brook.

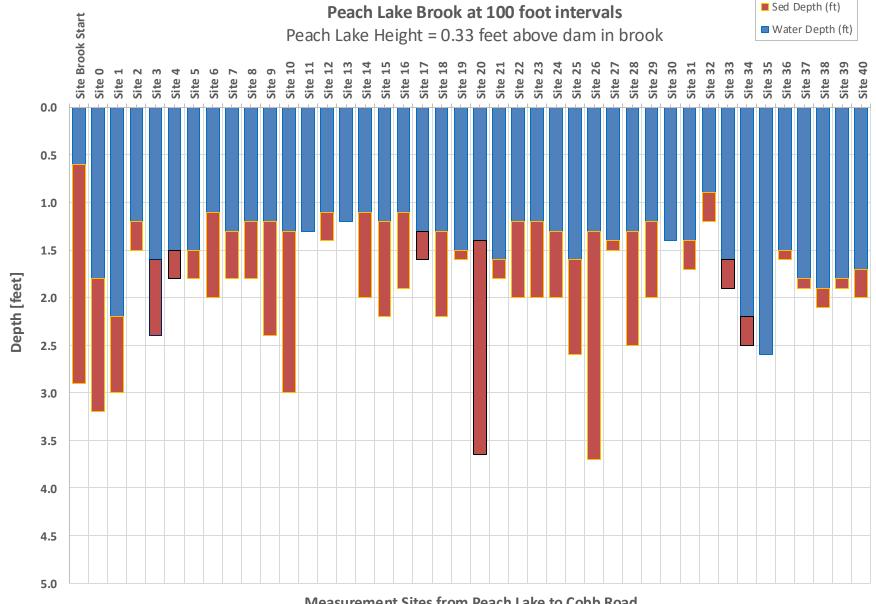
Water & Sediment Depth May 2024

- Detritus and root pack
 were removed during
 vegetation removal and
 soft sediments were able to
 be swept downstream with
 resulting increased flows.
- There was a significant reduction in fine sediment layer within the brook following the project.

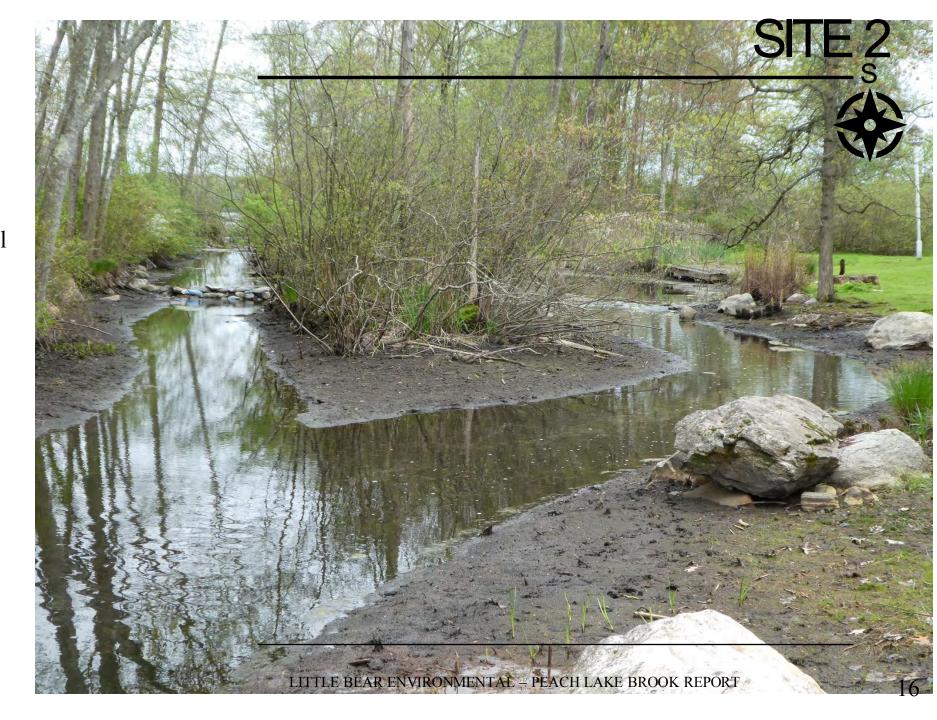
May 2024 Post-removal

• Photo showing the eastern channel with the unauthorized makeshift dam (left) and the original channel with the historic dam (right).

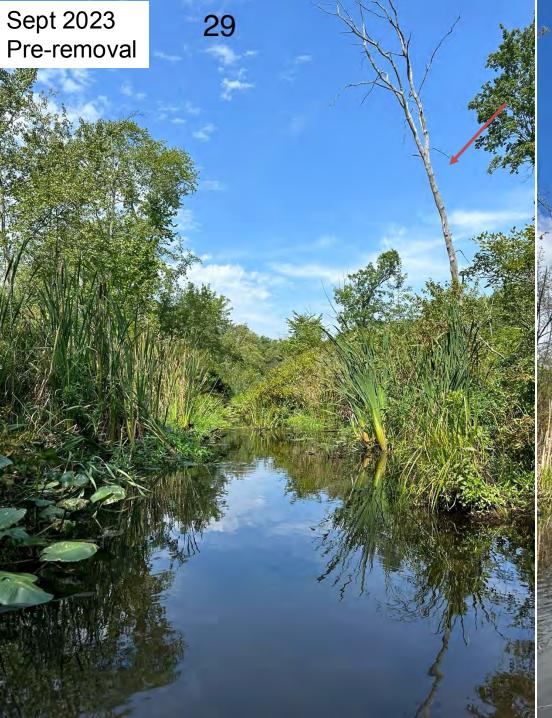
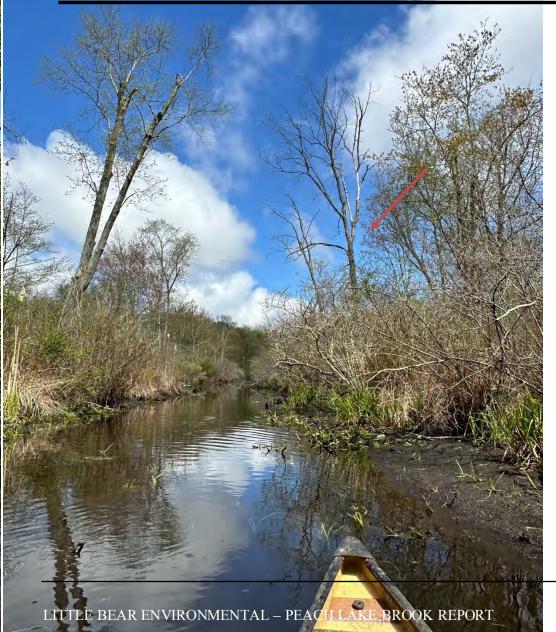
Site 29

May 2024 Post-removal

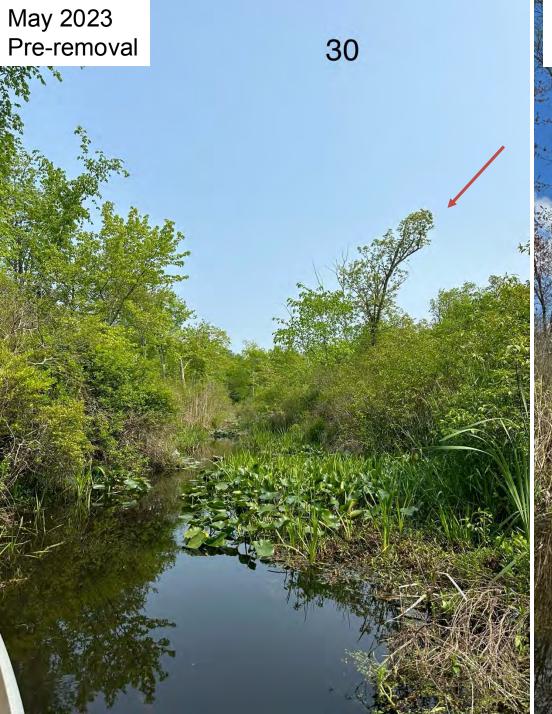
May 2024 Post-removal Site 30

Significant emergent vegetation removed, trace vegetation still present within channel

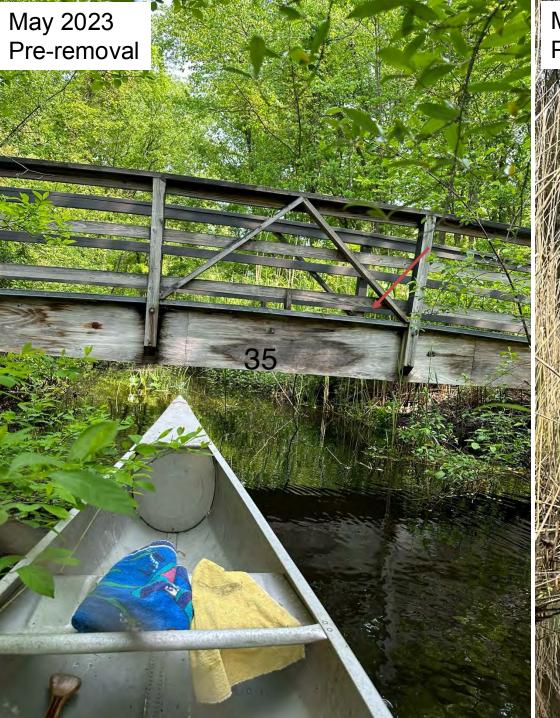
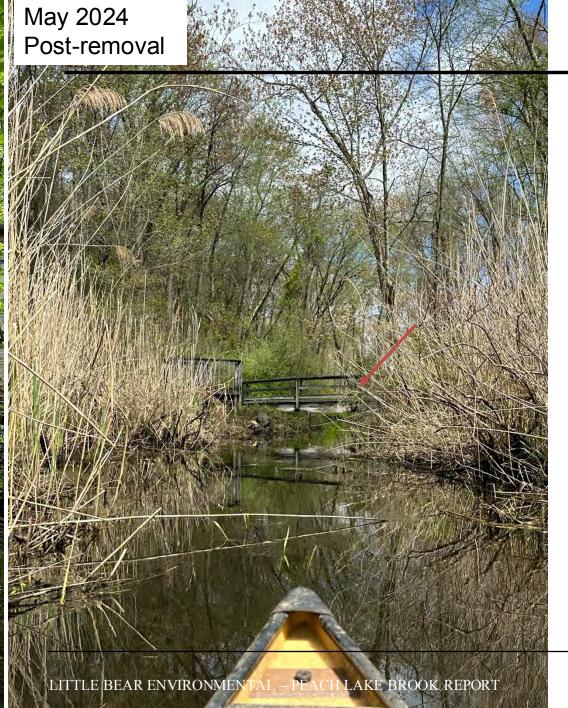
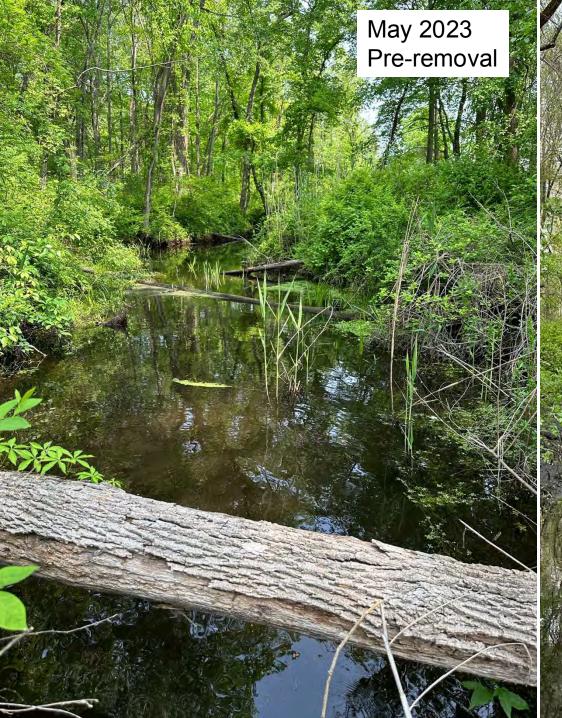
- No Nuisance densities
- Large woody debris removed from channel
- Water no longer stagnant
- No floating plants accumulating

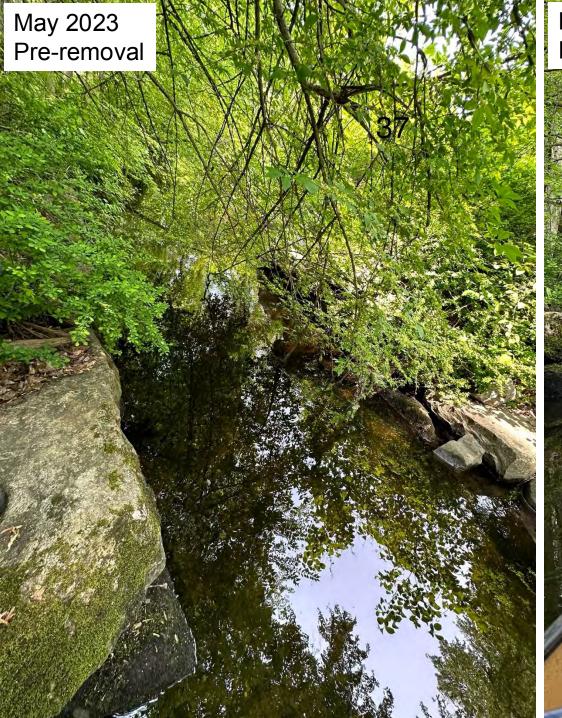
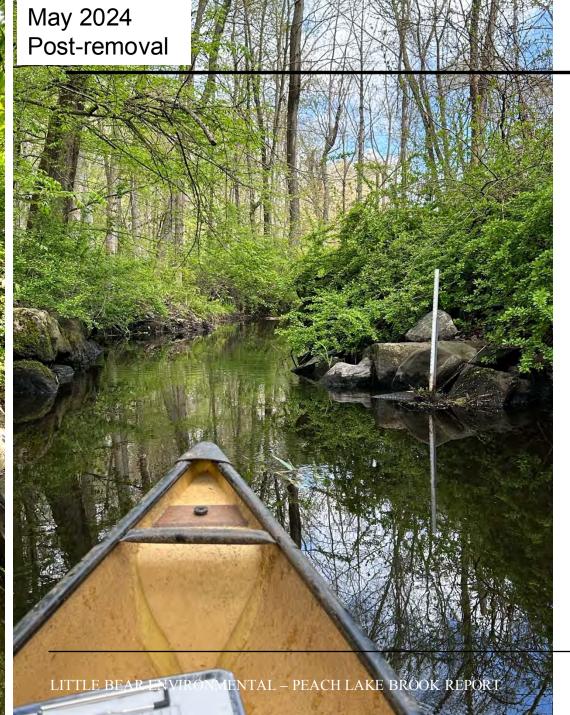
- No Nuisance densities
- Large woody debris removed from channel

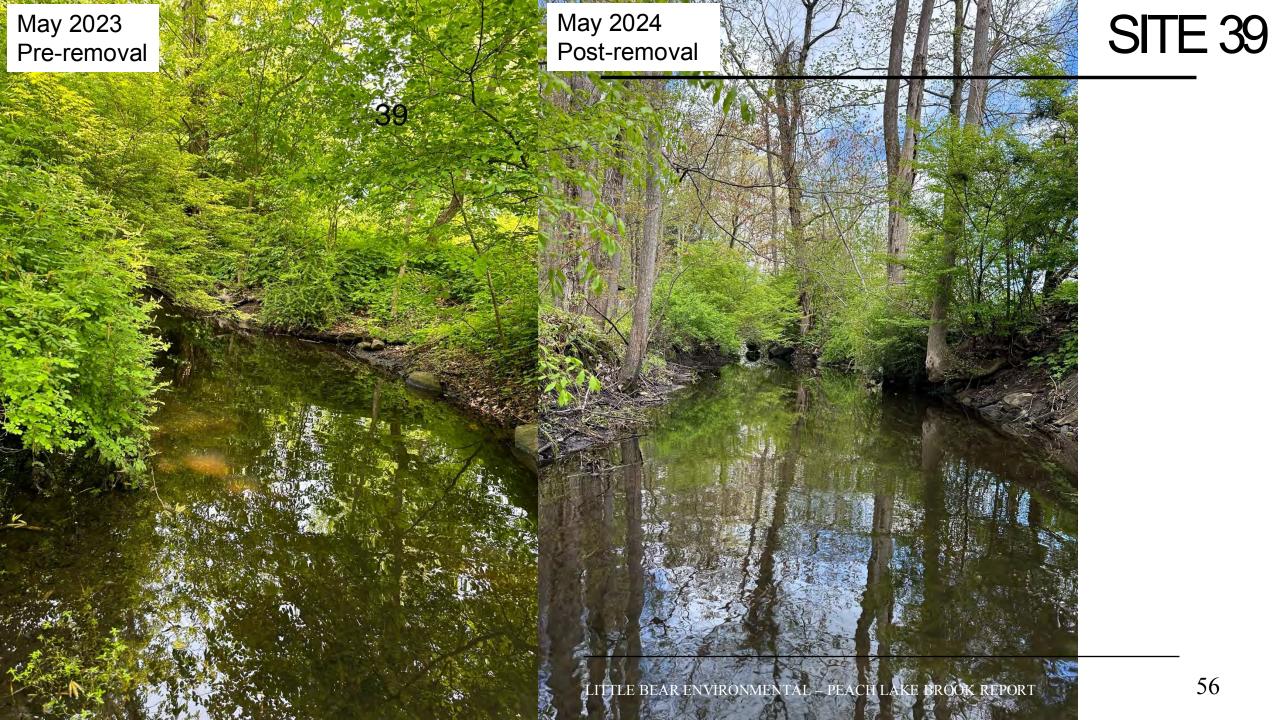
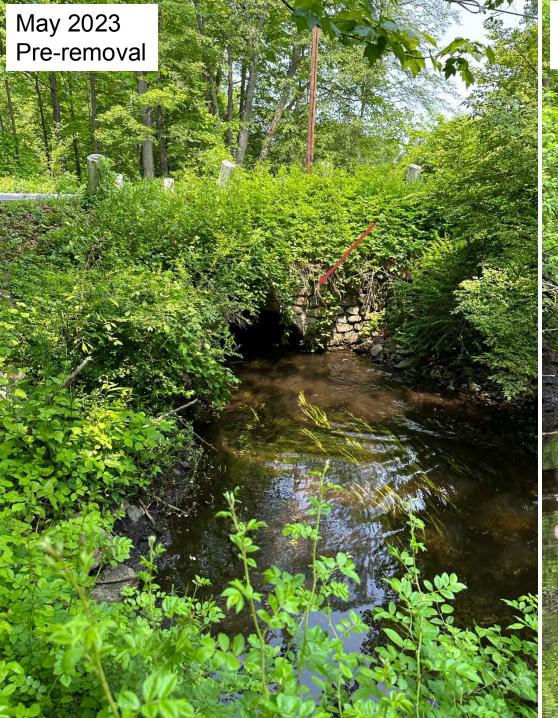
- No Nuisance densities
- Large woody debris removed from channel

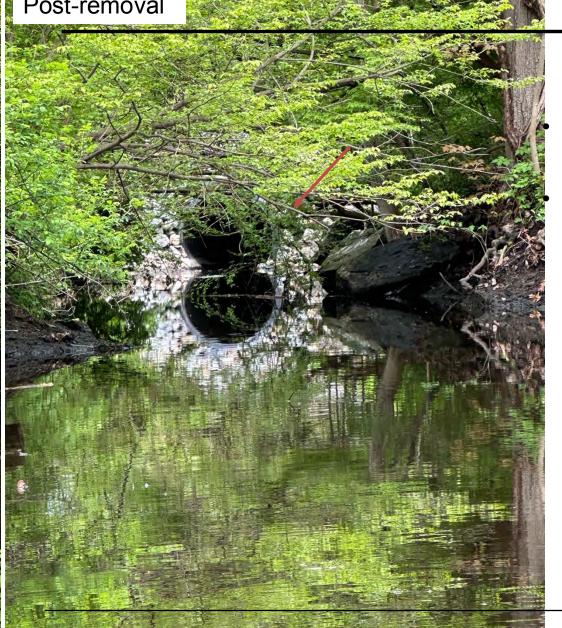
SITE 40

No Nuisance densities

Culvert has been upgraded since 2023 survey and now has two pipes.
